## Take a Peek Inside the MVSD Lab!

# Moorhen Marsh Western Pond Turtle Enhancement Project Making Progress

## Biotower Rehabilitation Project Nears Final Completion

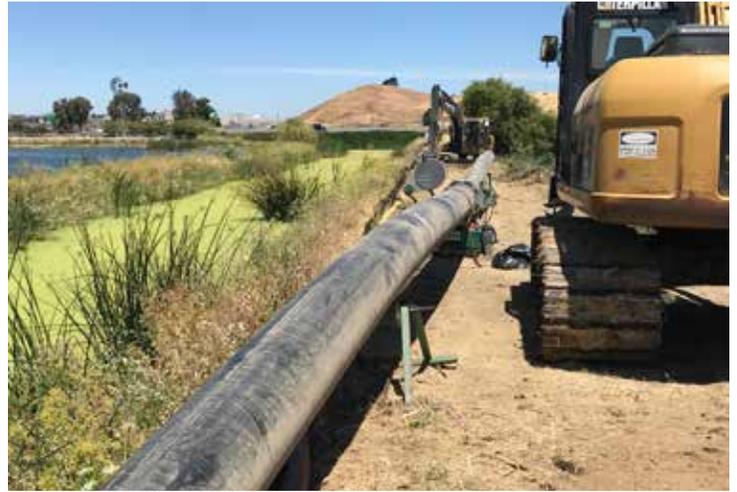
The contractor here is fusing HDPE bypass pipe for Peyton Slough.

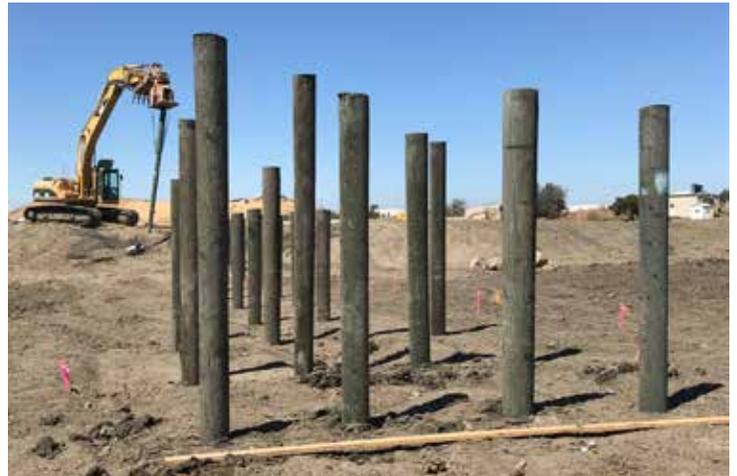
Installing piles in pond A2 - These piles will support the boardwalk and viewing platform.

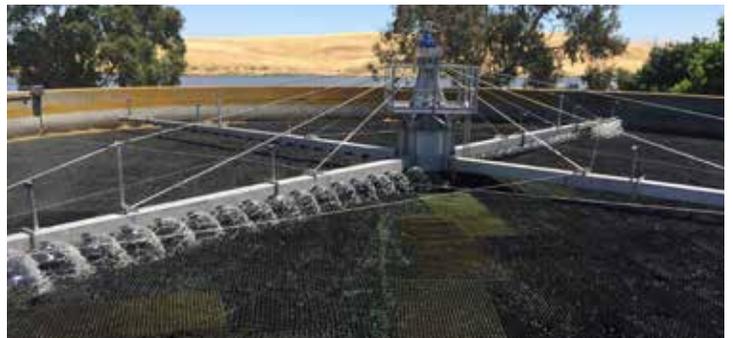
New center column and distributor arms spreading wastewater over media.

So what is a Biotower? The Biotower is a 100-foot diameter by 27-foot high cast-in-place concrete structure with cement masonry unit (CMU) walls. The Biotower is fitted with plastic media that is 22-feet deep and supported on precast concrete support beams tied into the base slab. The media consists of plastic material that provides substrate for the different “bugs” that are ultimately

responsible for removing ammonia from the wastewater. Effluent flow from the Biofilter and the recycle flow from the Biotower are distributed over the media by rotating distributor arms. A 4 foot square by 22 feet-high cast-in-place concrete pedestal provides vertical and lateral support for the influent distributor mechanism. Both the Biotower and Biofilter are trickling filters that provide removal of Total Suspended Solids and Biochemical Oxygen Demand. The crucial function of the Biotower is ammonia oxidation, or “nitrification,” which is ultimately the removal of ammonia. The bugs oxidize or change ammonia to nitrite and nitrate, thereby reducing the toxicity of the water.
