MT. VIEW SANITARY DISTRICT

WASTEWATER OPERATIONS MANAGER'S REPORT

TO: Mt. View Sanitary District Board of Directors
FROM: Scott Biocic, Wastewater Operations Manager
DATE: March 13, 2025
SUBJECT: Monthly Report February 2025

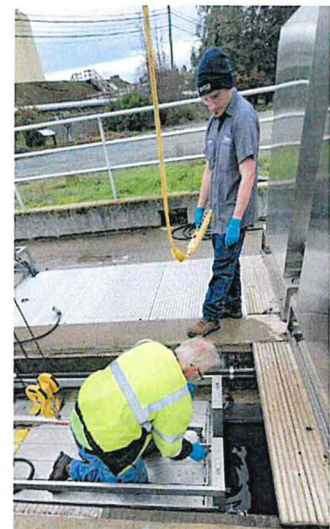
Staff replaced five UV (ultraviolet) lamps in the UV system Channel 2.

The picture on the right shows the lamp replacement in progress.

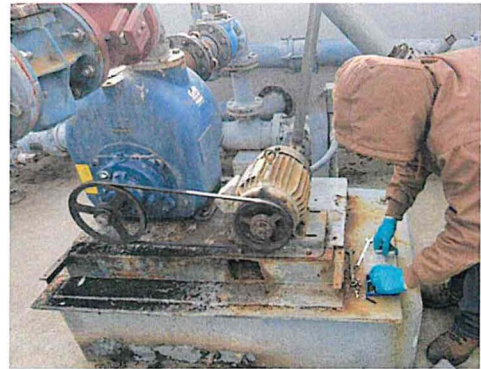
Staff discovered and repaired a cracked pulley on sludge pump #3.

The picture on the right shows the pulley being repaired.
